Wetland and WUS Delineation and Environmental Sampling Report

Teach AML Reclamation Project

Ottumwa, Iowa

Terracon Project No. 08127120

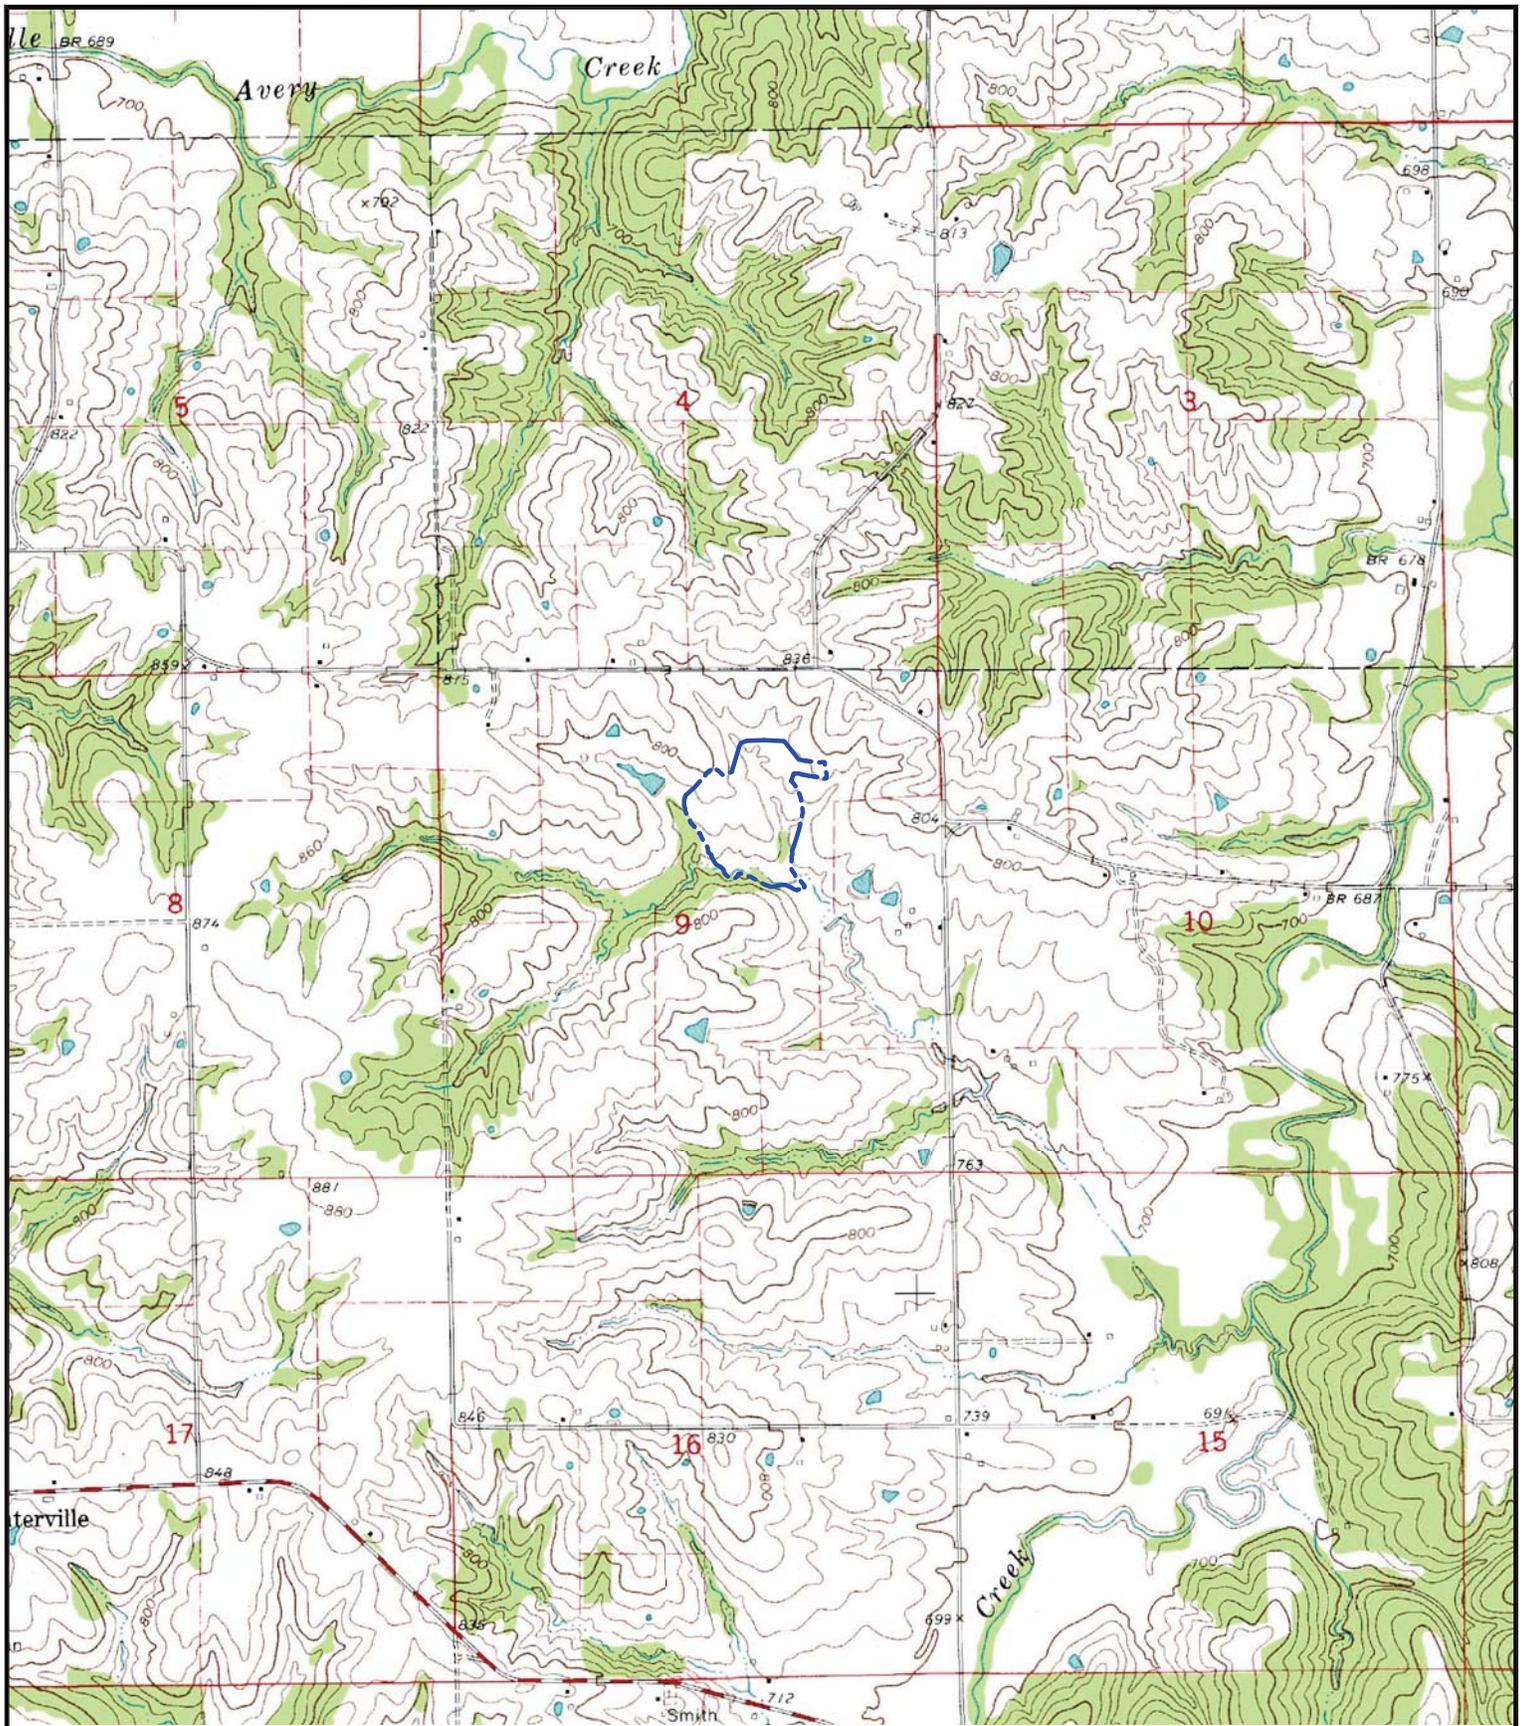
TOPOGRAPHIC SITE MAP	EXHIBIT
TEACH AML RECLAMATION PROJECT TRIYHDRO CORPORATION 220TH AVENUE OTTUMWA, IOWA	1

The United States Department of the Interior Geologic Survey (USGS) 7.5-Minute Topographic Map of the subject site was reviewed to identify drainages or WUS within the project area. A portion of the *Chillicothe*, Iowa Quadrangle can be seen as Exhibit 1 in Appendix A. As shown on Exhibit 1, an intermittent tributary is adjacent to the south side of the site.

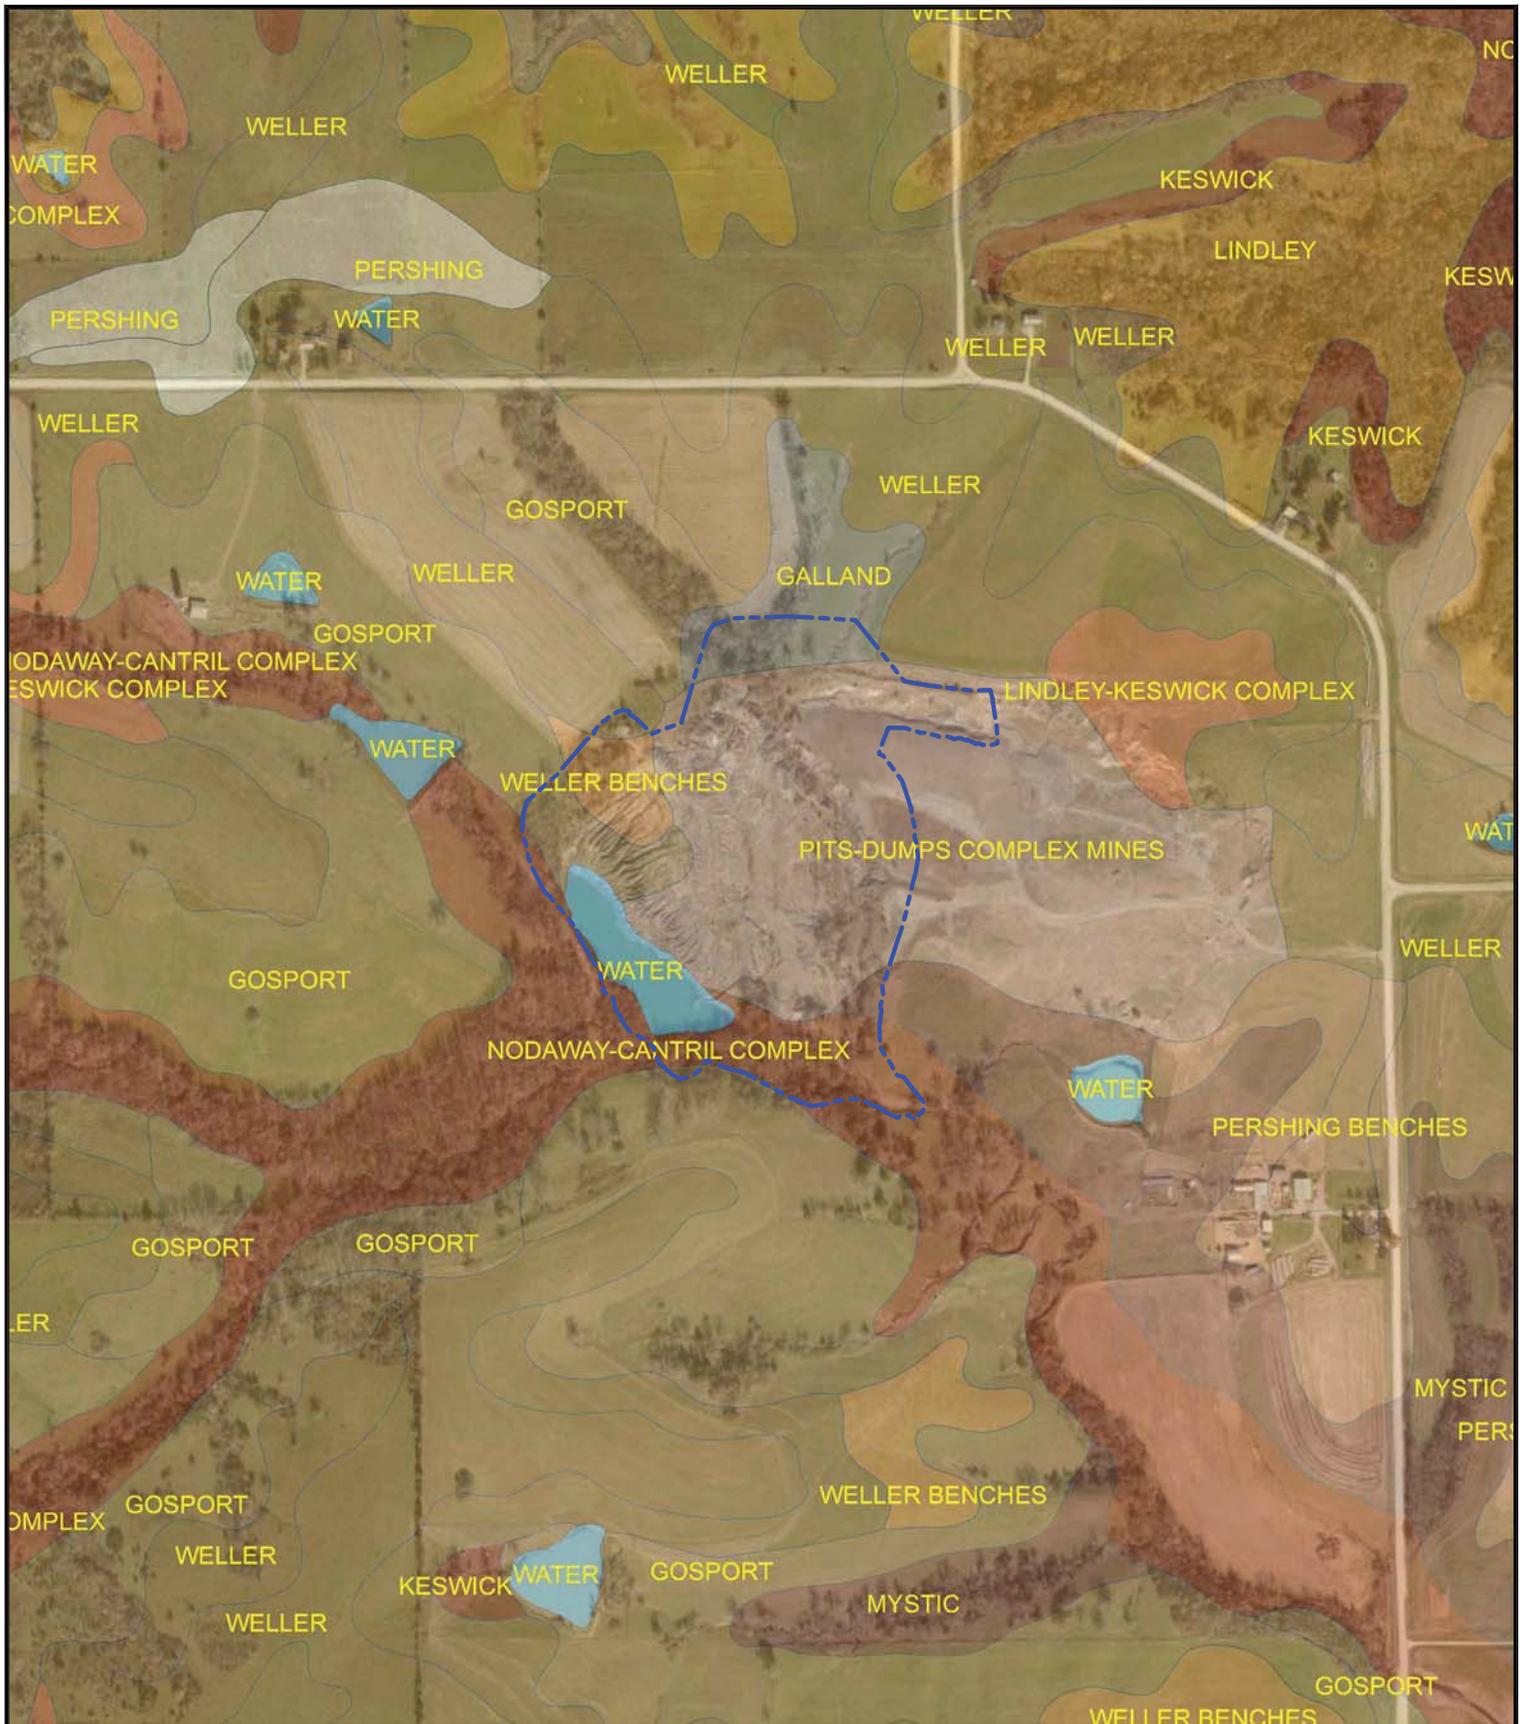
SOIL SURVEY MAP	EXHIBIT
TEACH AML RECLAMATION PROJECT TRIYHDRO CORPORATION 220TH AVENUE OTTUMWA, IOWA	3

(WSS)¹ to identify soil types and hydric soils. The NRCS soil survey map can be seen as Exhibit 3 in Appendix A; however, this map does not depict all of the identified soil types found in the WSS.

The following soil types were identified within the project area based on an area of inquiry search of the WSS:

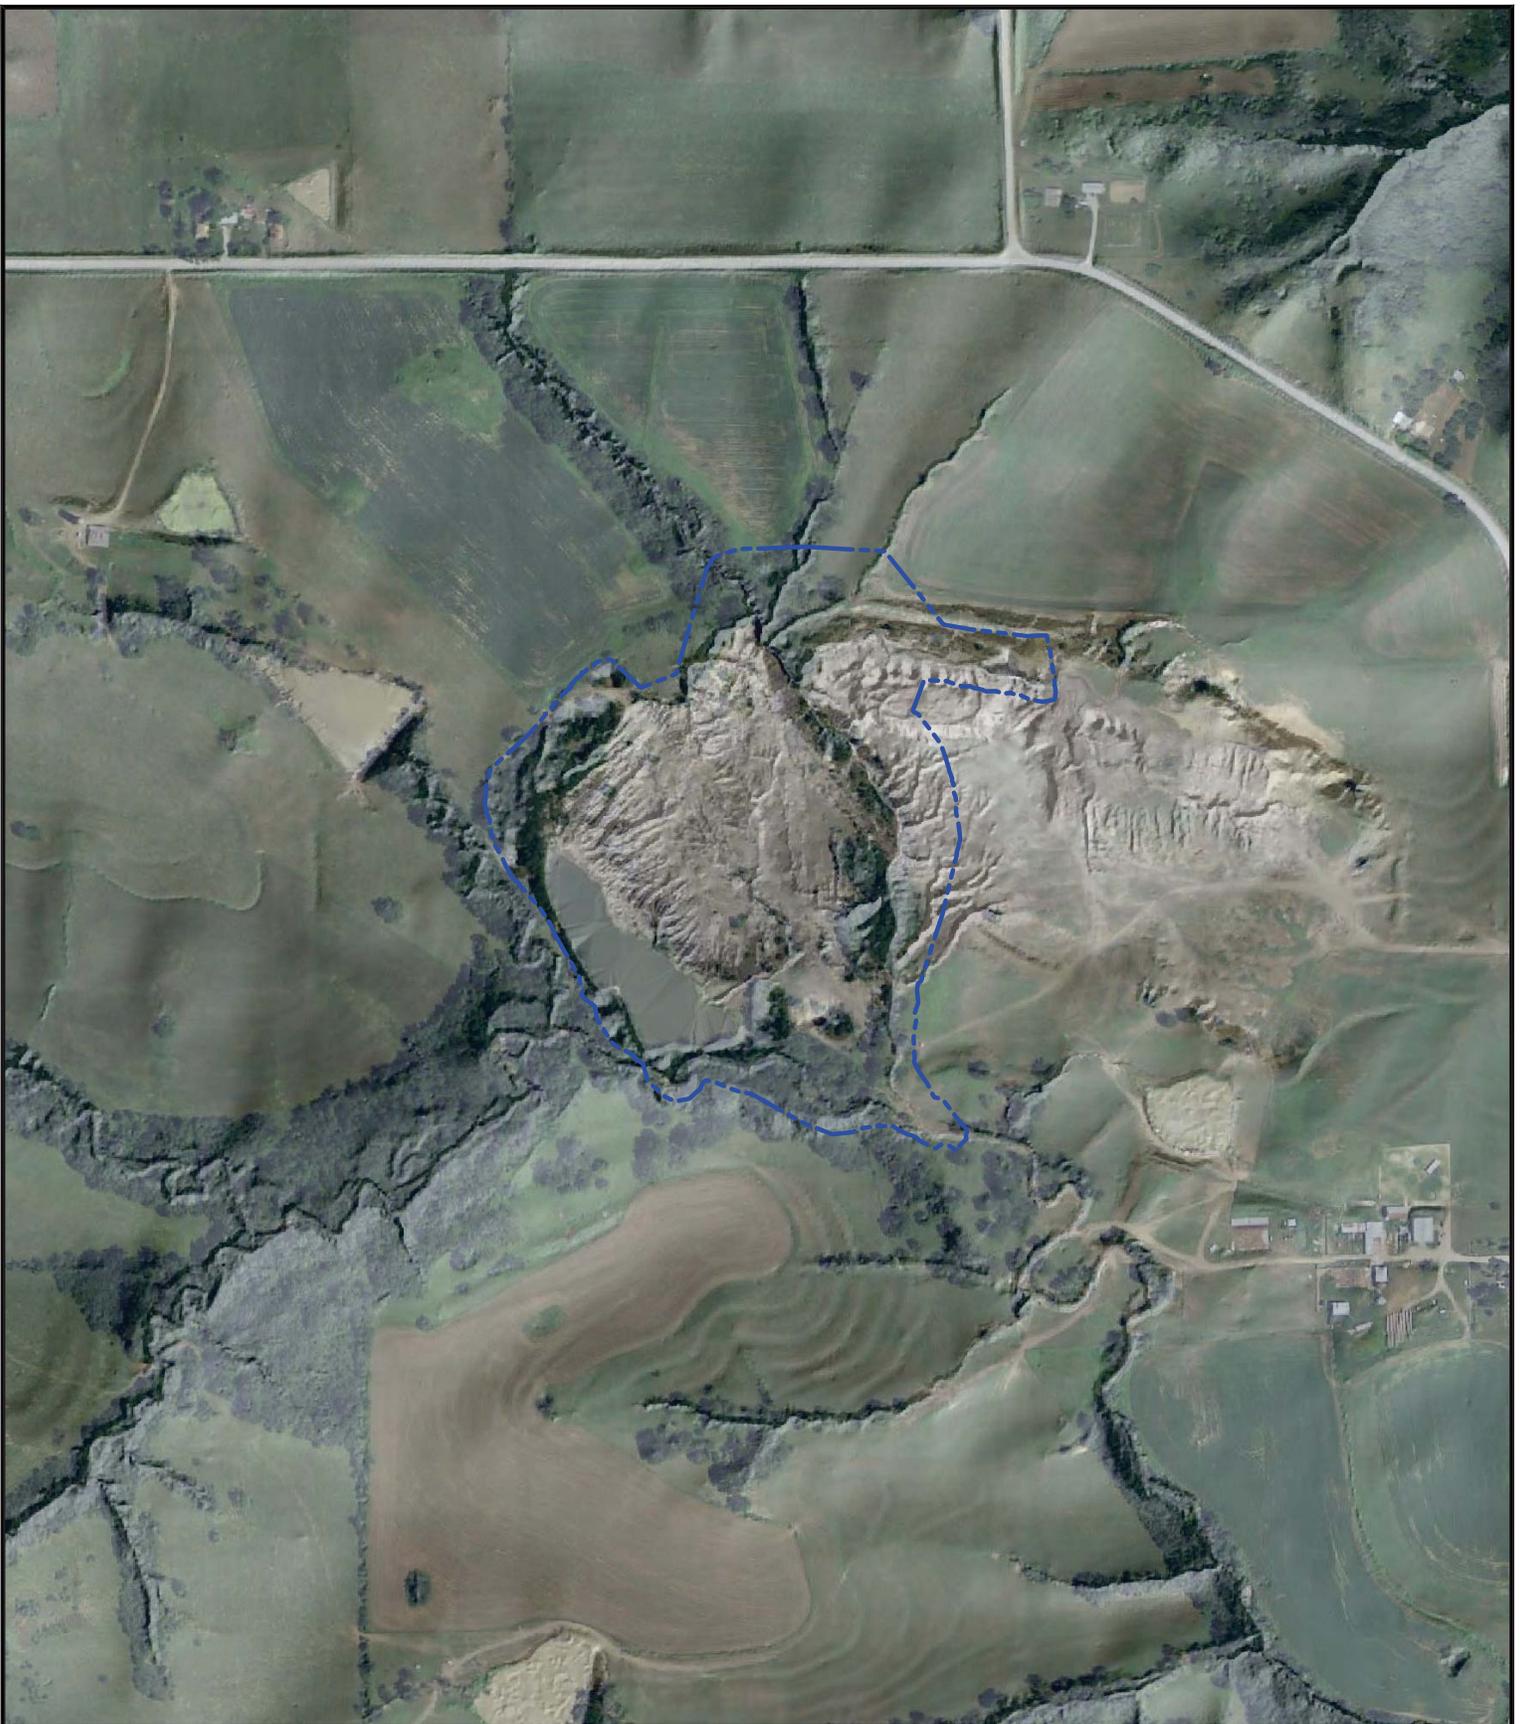
HILLSHADE FROM LIDAR AND AERIAL PHOTO	EXHIBIT
TEACH AML RECLAMATION PROJECT TRIYHDRO CORPORATION 220TH AVENUE OTTUMWA, IOWA	4

Terracon reviewed the Hillshade Map of the site obtained from the ISU GIS Support and Research Facility to assist in identifying potential lowland areas. The Hillshade Map uses Light Detection and Ranging (LIDAR) data to depict the approximate topography of the site. The Hillshade Map, including a transparent aerial photograph, can be seen as Exhibit 4 in Appendix A. As shown on Exhibit 4, the site consists of a highly disturbed area with several drainage channels.

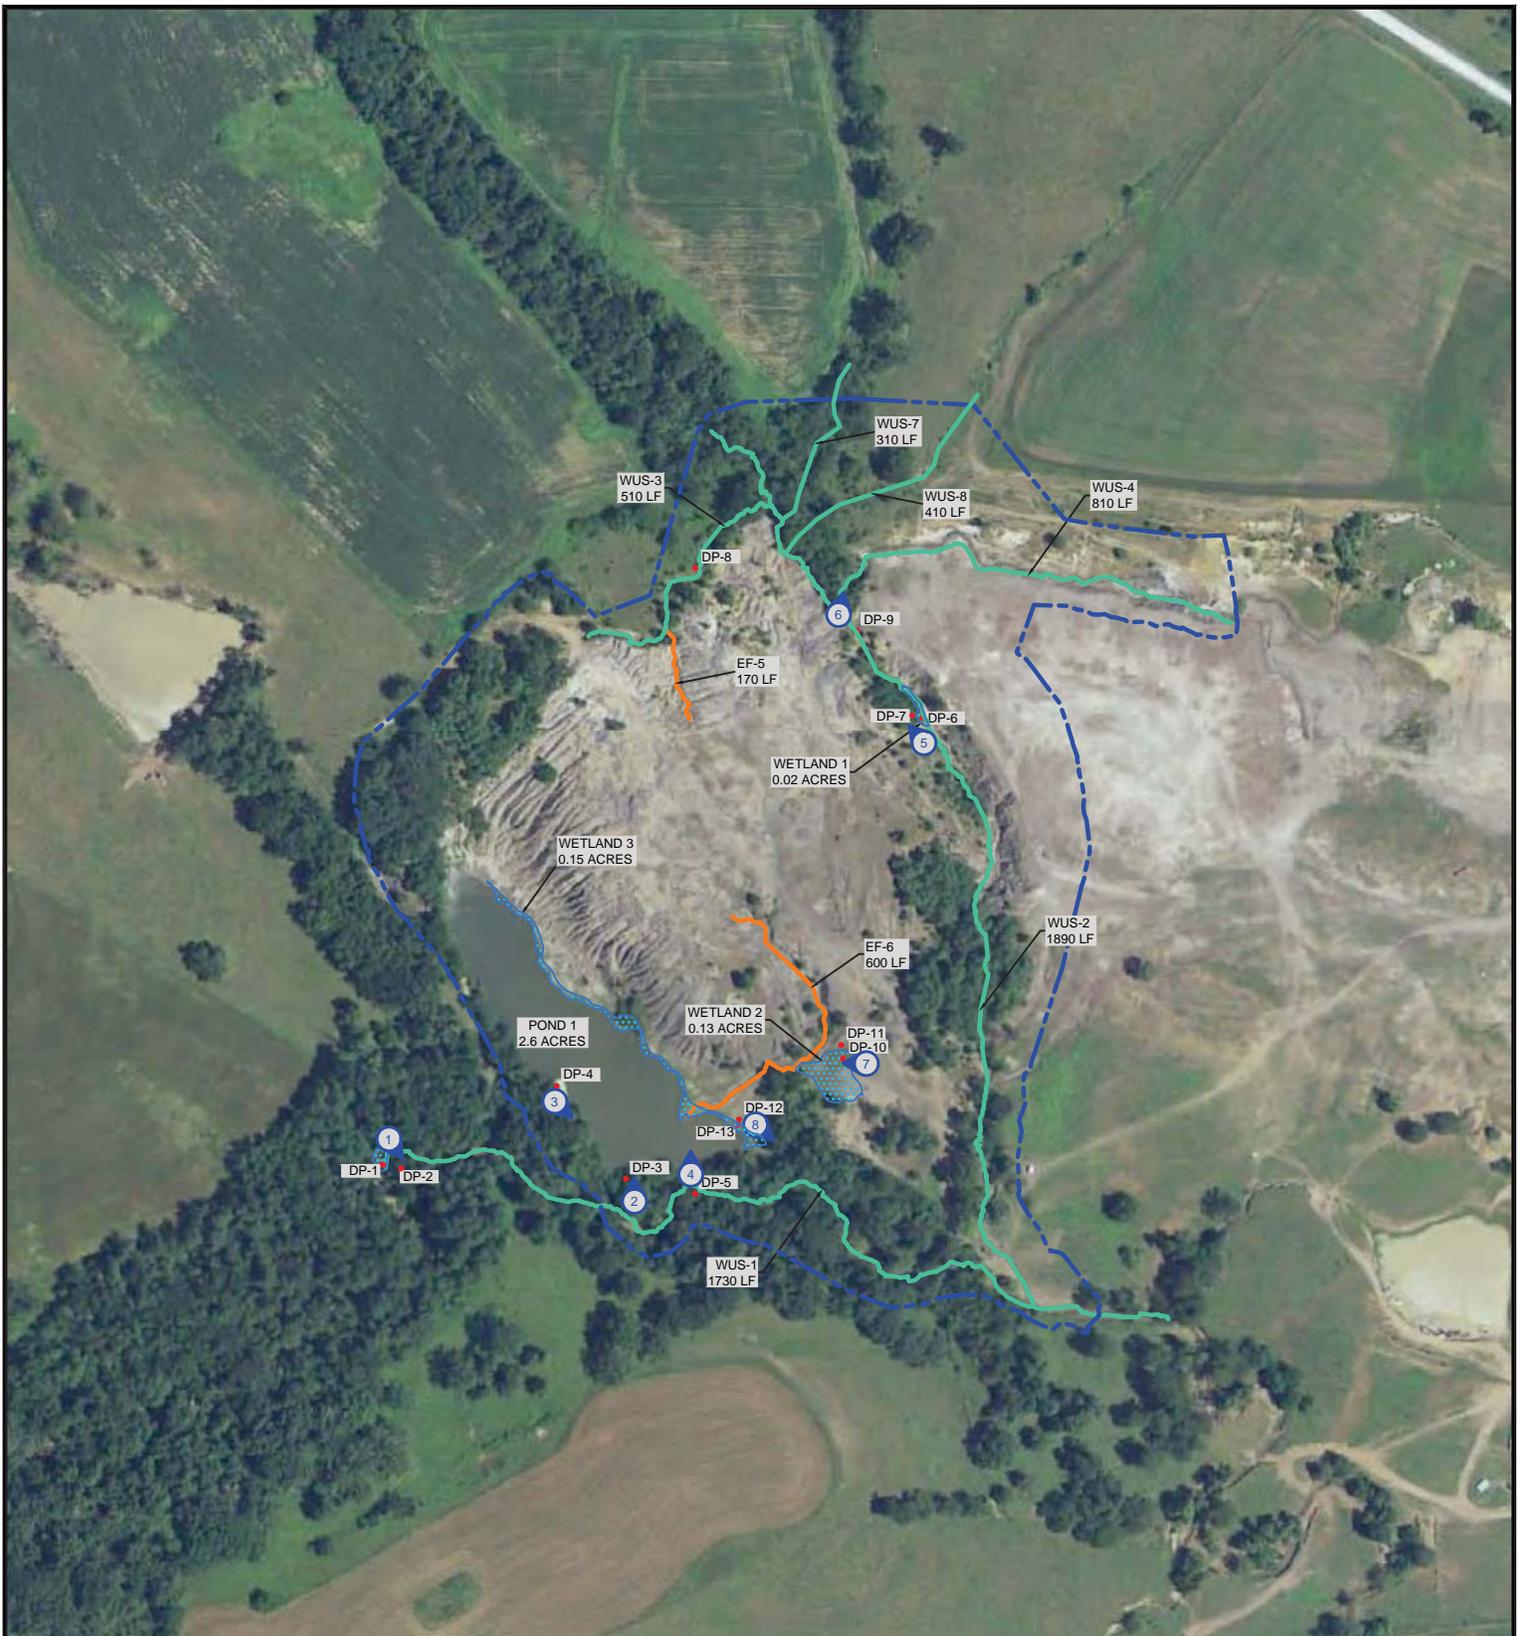
On November 7, 2012, Terracon performed fieldwork and identified three wetland areas, six WUS, two erosional features (EF), and one pond on the subject site. The areas are designated as Wetland Areas 1 through 3, WUS-1 through WUS-4, EF-5, EF-6, WUS-7 and WUS-8, and Pond 1 as shown on Exhibit 5 in Appendix A. A fourth wetland was identified outside of the project limits. Wetland Determination Data Forms for each wetland area can be found in Appendix C. Ground photographs, included in Appendix D, provide an indication of the physical characteristics observed during the site visit.

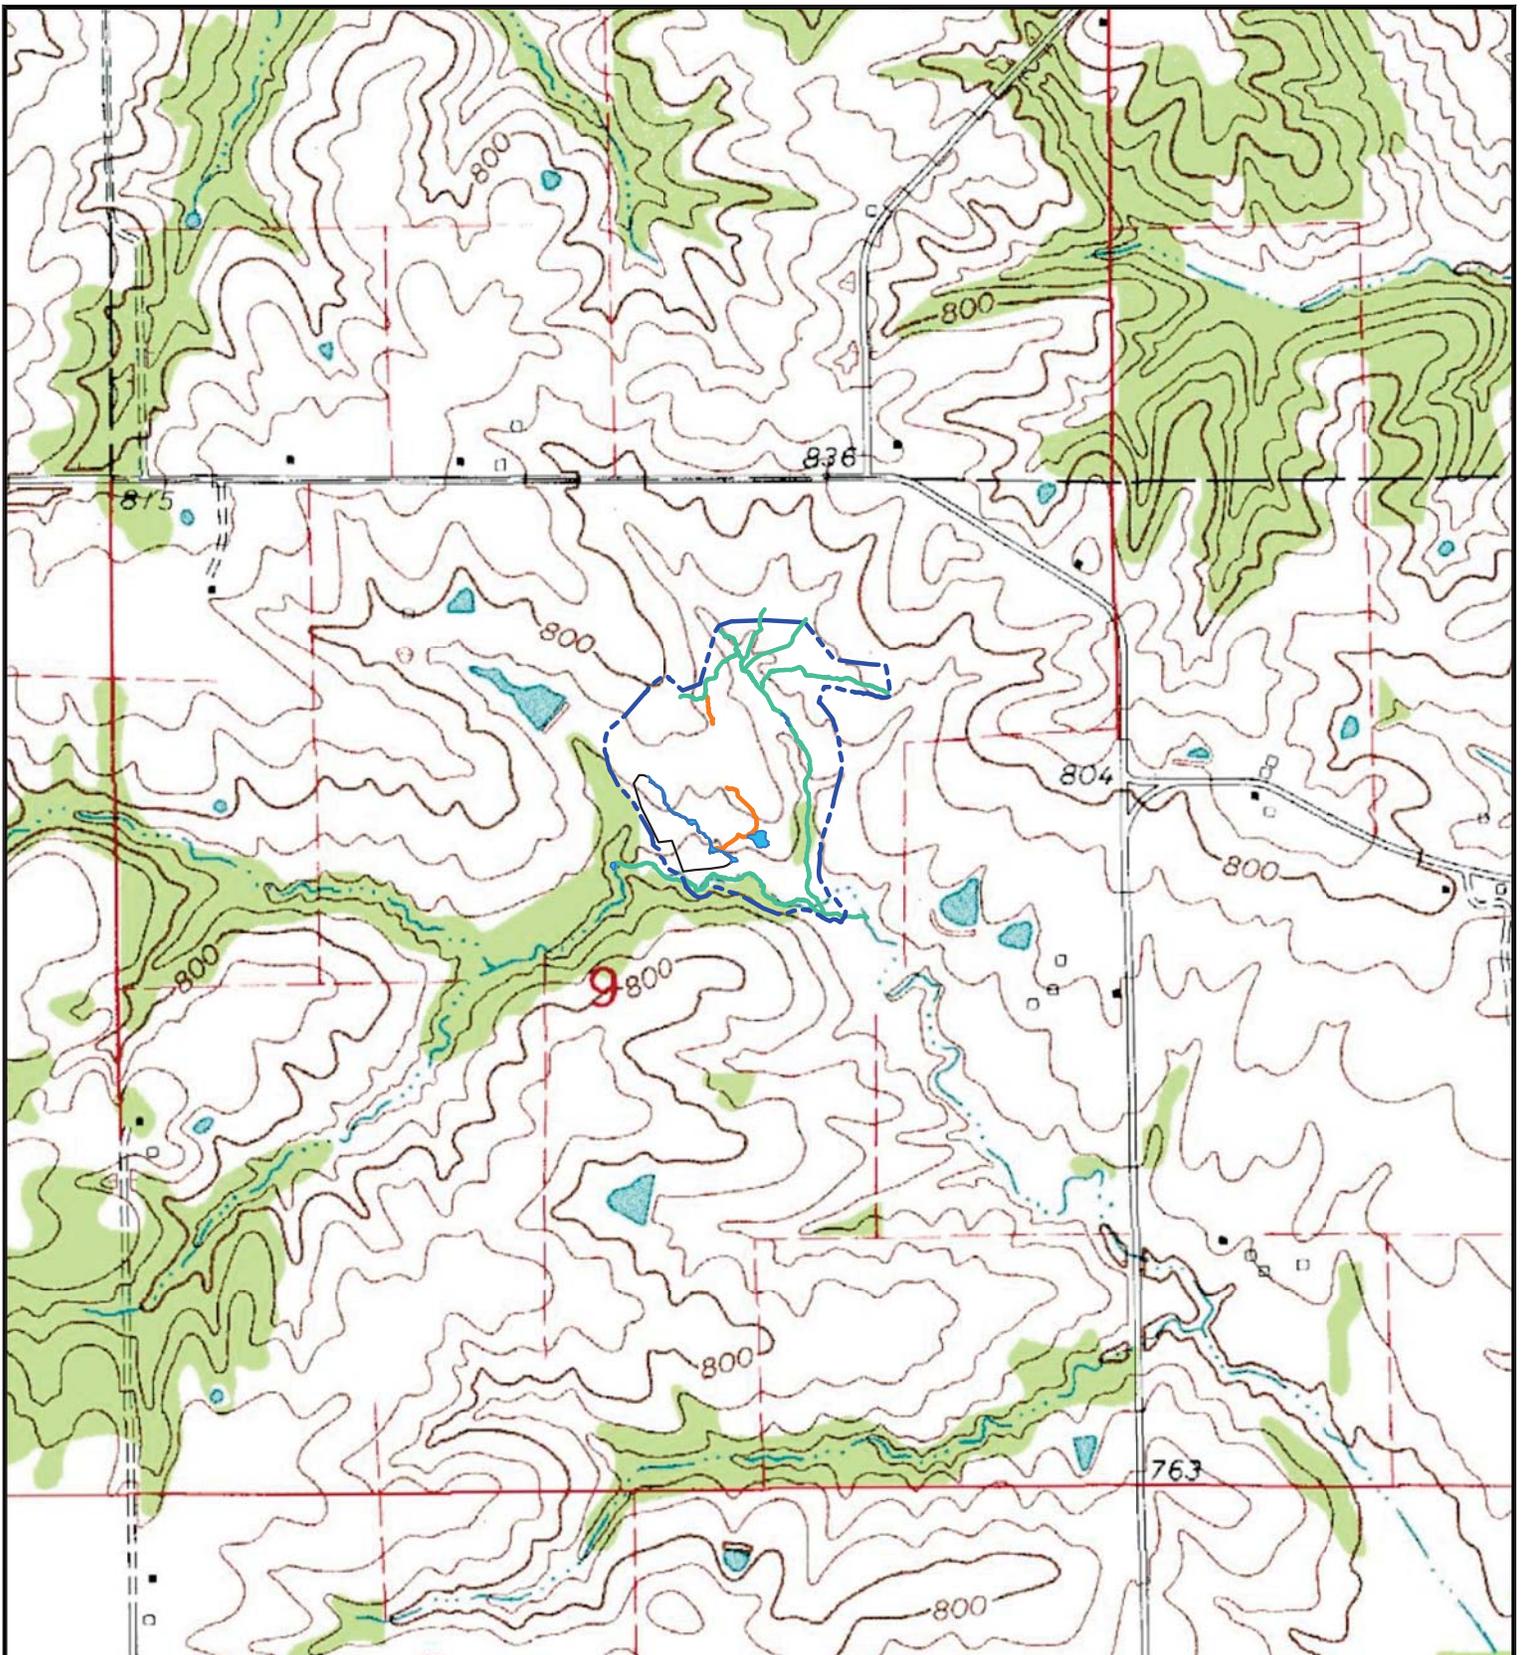
throughout the wetland area to define the wetland/non-wetland boundary, which was mapped with GPS technology or flagged and surveyed by traditional methods. Vegetation, soil and hydrology assessment data from at least one location within the wetland and one upland location outside of the wetland were recorded on a USACE Wetland Determination Form. The recorded data forms for the subject site can be found in Appendix C and the data point location can be seen on Exhibit 5 in Appendix A. The wetland locations plotted on the USGS topographic map can be seen as Exhibit 6 in Appendix A.

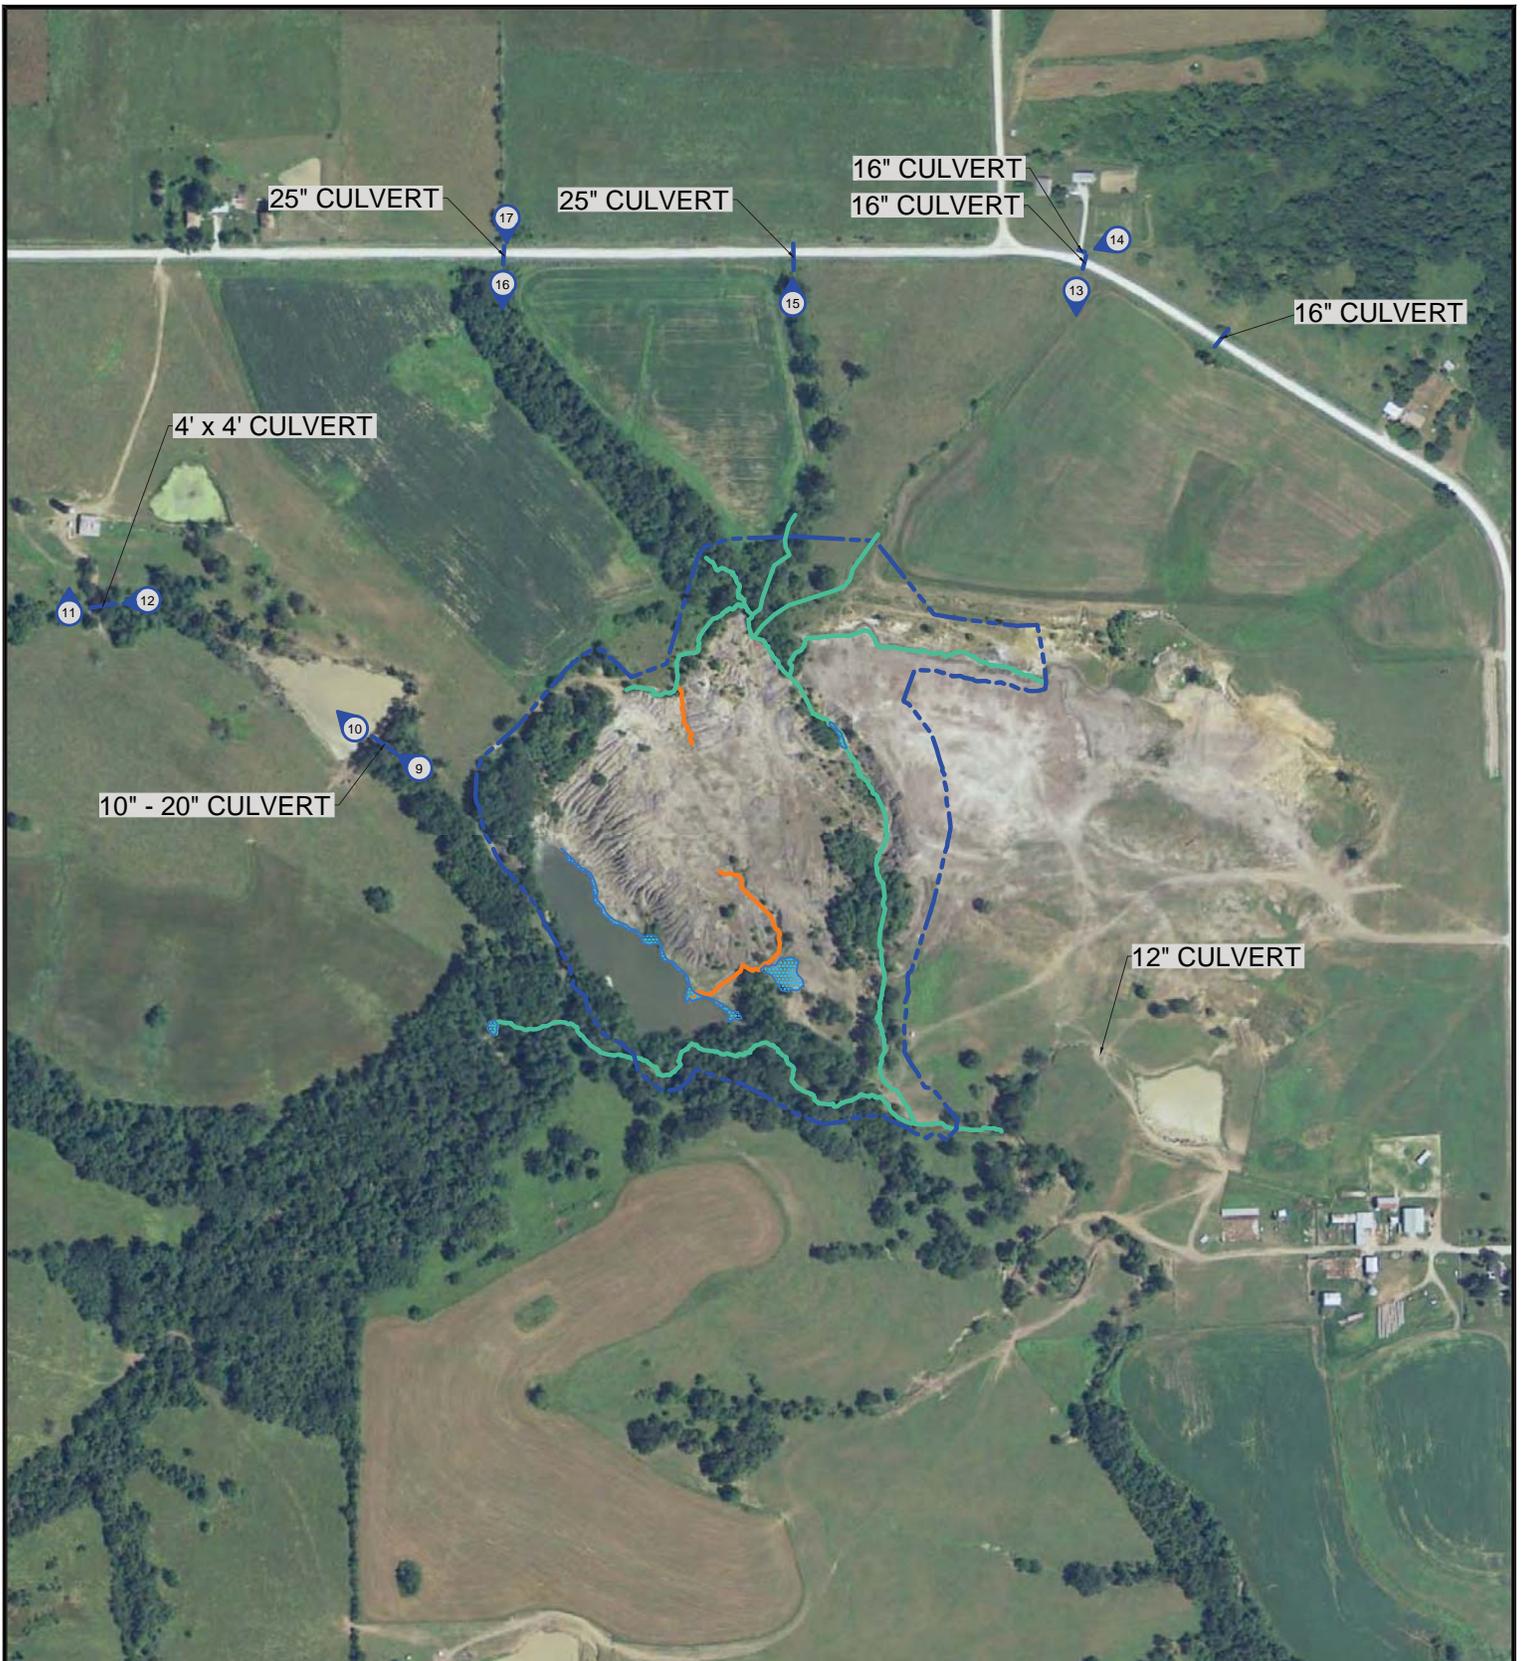
EXHIBIT
7

During the site visit, Terracon collected size information for upstream controls (e.g. culverts, weirs, or road crossings) that may affect the amount of water reporting to the creek on the east side of the site. Eight culverts were identified within approximately 2,000 feet of the site. The culvert locations and sizes can be seen on Exhibit 7 in Appendix A. Photos of the culverts can be found in Appendix D.
